# Deer Creek Ranch Parks & Lakes Association

**2019 Annual Meeting: 10 AM Saturday, June 8, 2019**

## ***COMMUNITY NEEDS AND THE COMMUNITY CENTER***

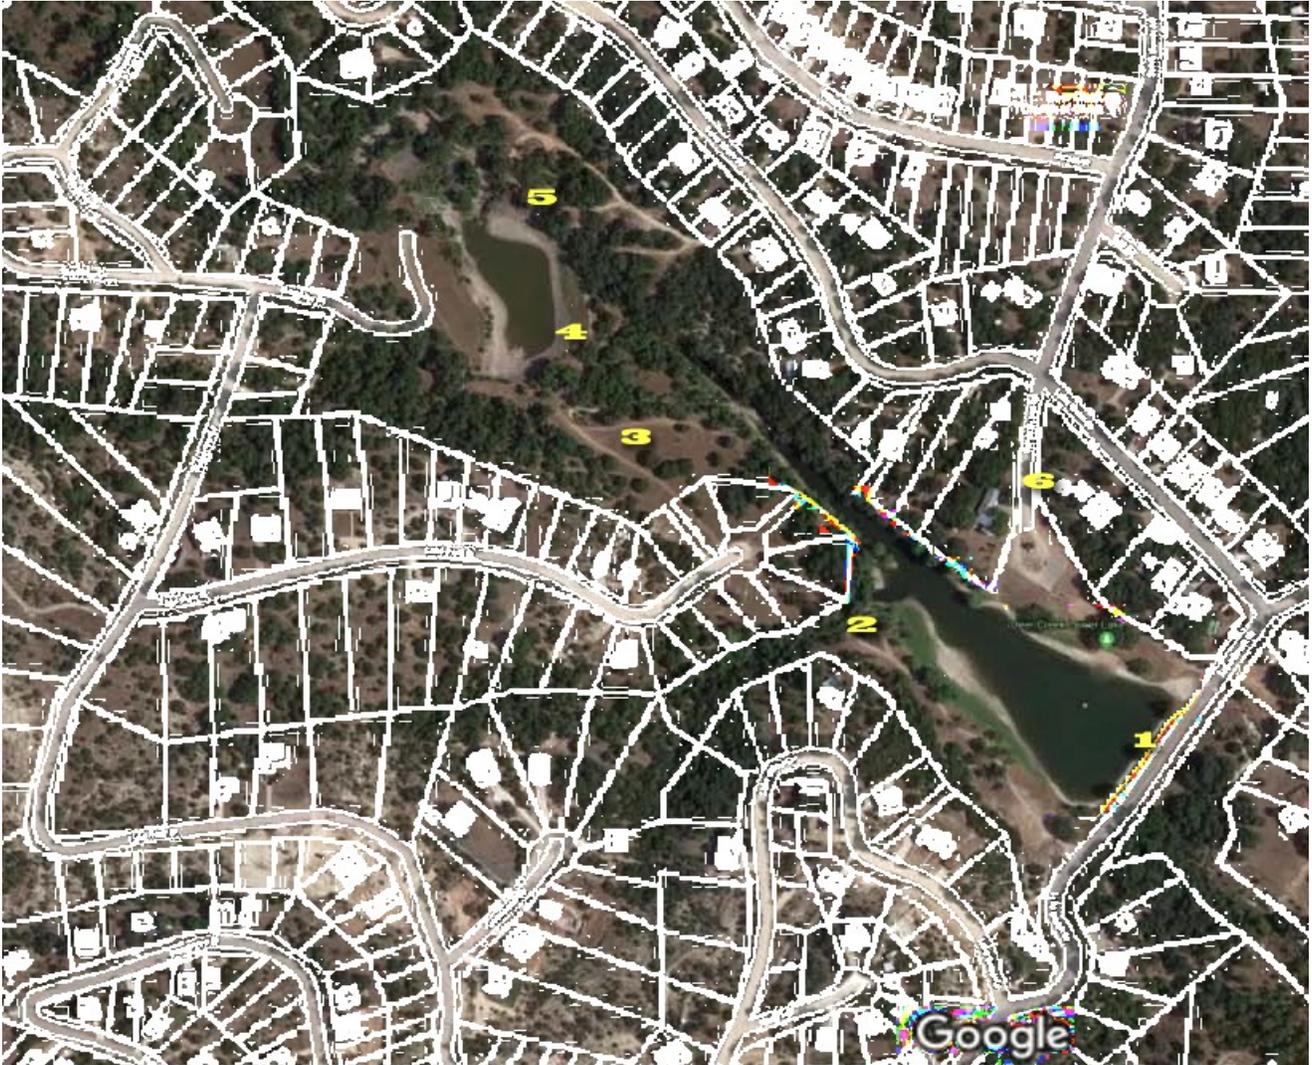
Deer Creek Ranch Parks & Lakes cover a great deal more area than is readily visible. Below is an overhead map identifying property lines and key features and responsibilities of the DCRPLA that will be discussed during this meeting. They are numbered for easy reference.

1. Lower lake dam
2. Lower lake fishing side and walking bridge
3. Open field between upper & lower lake
4. Upper lake spillway and walking bridge
5. Campground area
6. Entry to lower lake playground, beach, and volleyball areas

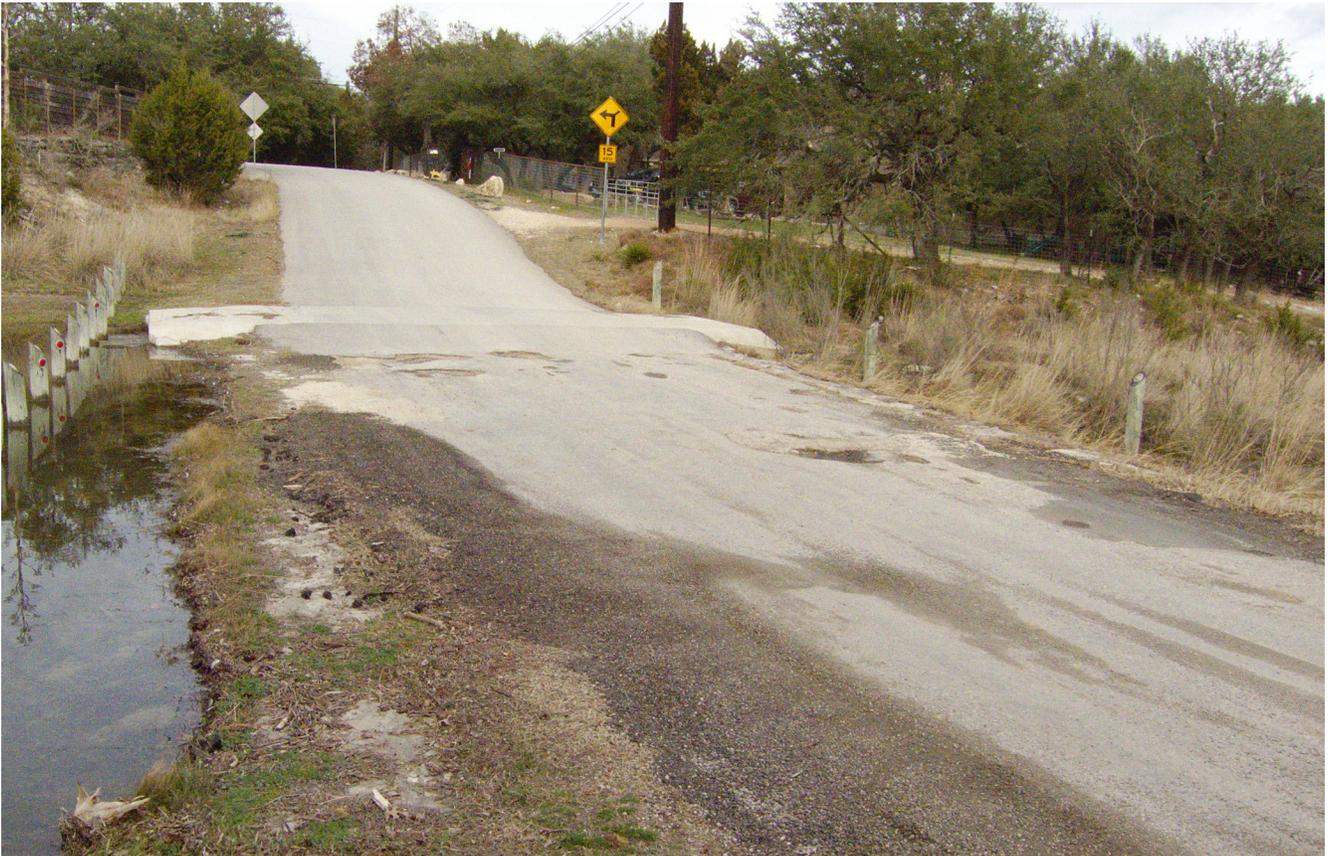
Issue #1. Lower segment of lower lake dam crossing. On Dec 31 Travis County patched large potholes that had opened in this portion of the dam. Only a couple days later, with more rains, the asphalt had already been washed away. The result wasn't much different than before the work had been done and is shown here:

*Although not obvious, this photo was taken only days after Travis County had completely patched potholes on lower section of dam road.*

Estimated cost is \$8,800 to do necessary concrete work in lower section of dam.

Resolving BOTH issues (repaving the entire dam the proper way that will last including the concrete work next to the current culverts) will be \$24,585.16.

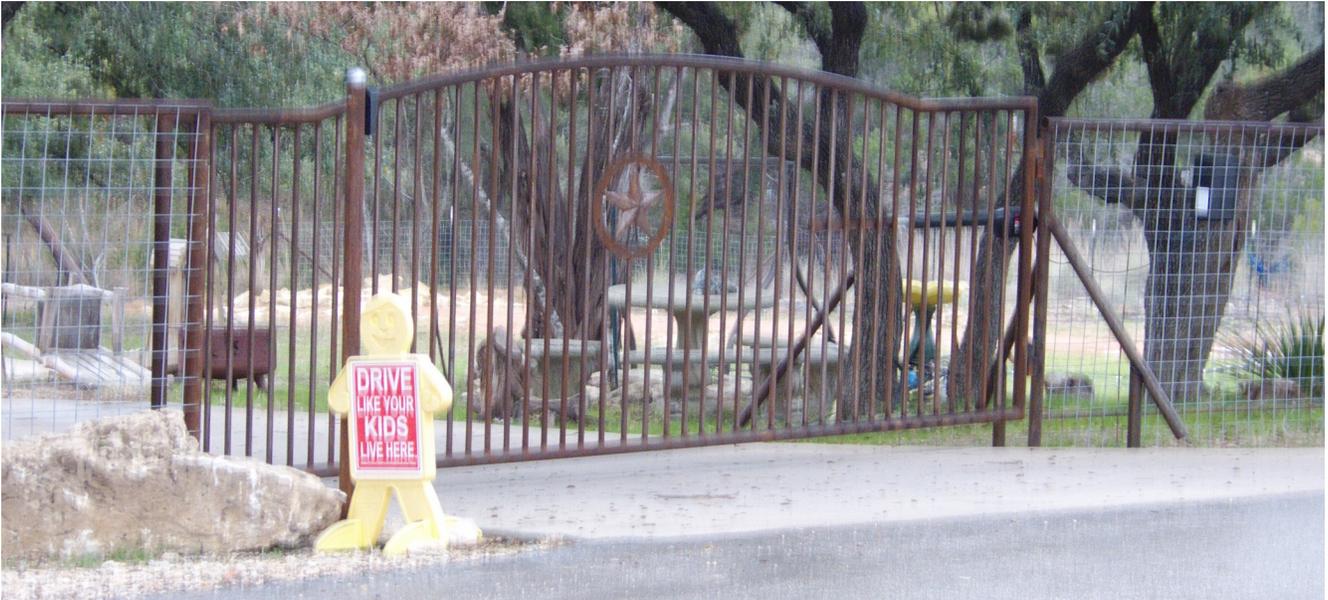
Opportunity #2. Gated access for vehicles. Access to the south side of the lower lake park presently requires that someone manually lock and unlock the gate every day. In addition to it not always getting locked at night, it does nothing to restrict access for non-members during the day. As part of a community pavilion, the board proposes an access gate.

*The above photo shows a representation of a moderately secure gate configuration proposed for inclusion with community pavilion.*

Estimated cost for pavilion with storage, electricity, Wi-Fi, and gated access is estimated to cost \$45,000.

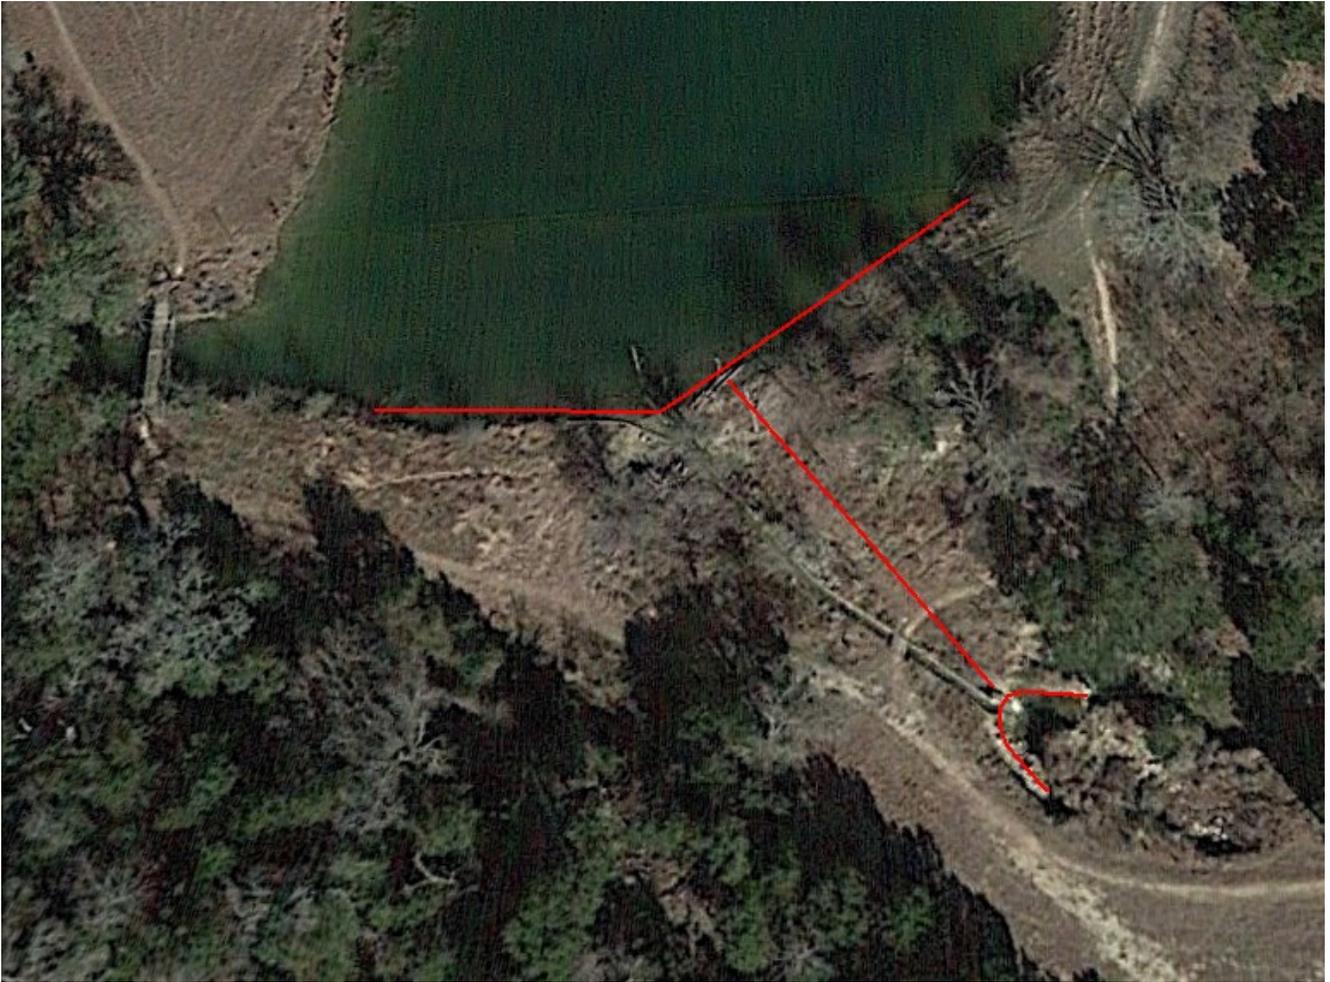
Key considerations: With the massive rainfalls over the last few months, the upper lake has regularly been exceeding its holding capacity, with mitigating counter-measures failing with increasingly visible frequency. This has resulted in rapid erosion of the ground designed to hold the water. The lake is overflowing its banks in the area represented by the “V.” The distance on the left of the existing outlet extends for approximately 60’ and to the right of the outlet extends for approximately 90’. The intended overflow region is the small concrete region at the bottom of the V.

Due to this erosion, the half-pipe culvert (located to the left of the straight line) intended to divert overflow toward the lower lake is not doing its job and water is frequently finding other paths into the overflow region (which is itself eroding) represented by the “C” outline. The land preventing catastrophic collapse (a complete emptying of the upper lake into the lower lake) is only ~ 100’ wide in some areas. Catastrophic collapse of the upper lake would mean losing a valuable asset, but would likely trigger a domino of catastrophes downstream. In a worst case scenario, it could trigger the collapse of the lower lake dam and the complete emptying of both lakes with flooding and potential impact to houses located in the flood plain (of which at least 4 are known).

*Above diagram shows the bank wall region where water overflows, the general path of the spillway, and the overflow region. Not shown is the pathway to the lower lake.*

To address both issues, the board proposes installing 3 Rock Cage Berms on either side of spillway half pipe to route water into correct path and prevent further erosion and washout.

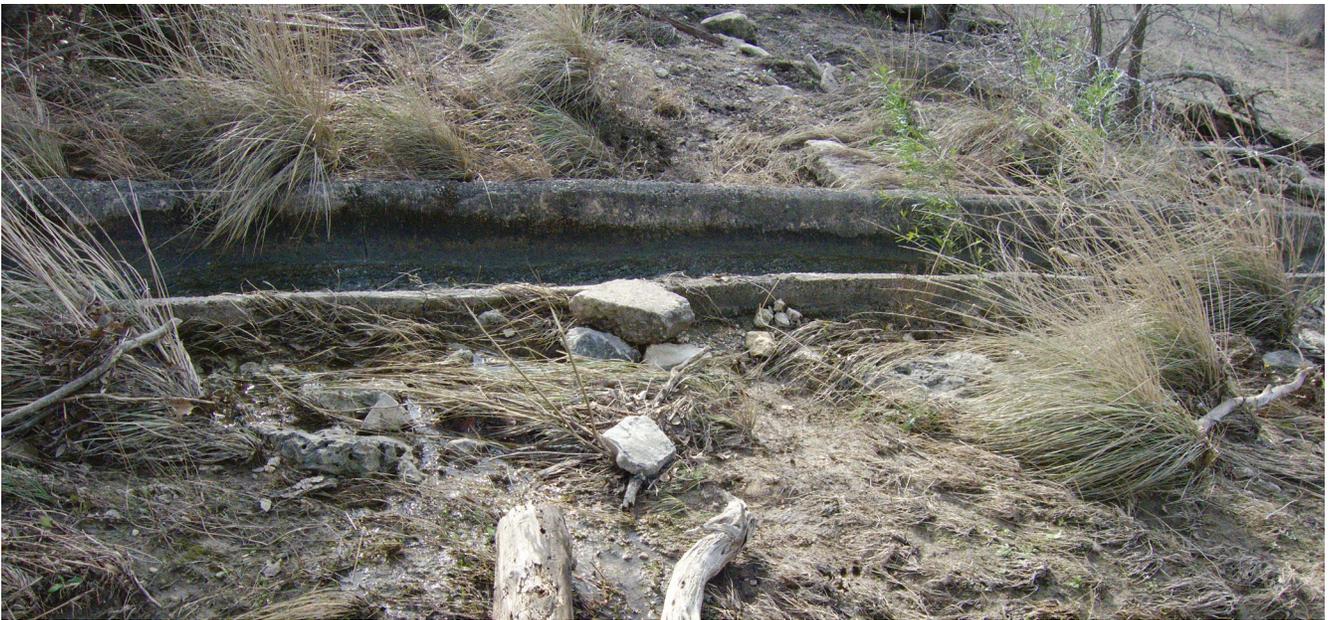
*The above photo illustrates how much of the exterior surface of the spillway is now exposed and how much ground has eroded. Water rushes along the ground on either side of the spillway.*

Issue #1. The spillway. As shown in the preceding pictures, the ground has now eroded below the spillway structure. Any water not collected at the mouth of the spillway has no means to re-enter the spillway and simply rushes across the ground to the lowest point. This problem is rapidly worsening with each rainfall.

Estimated cost: \$5,000

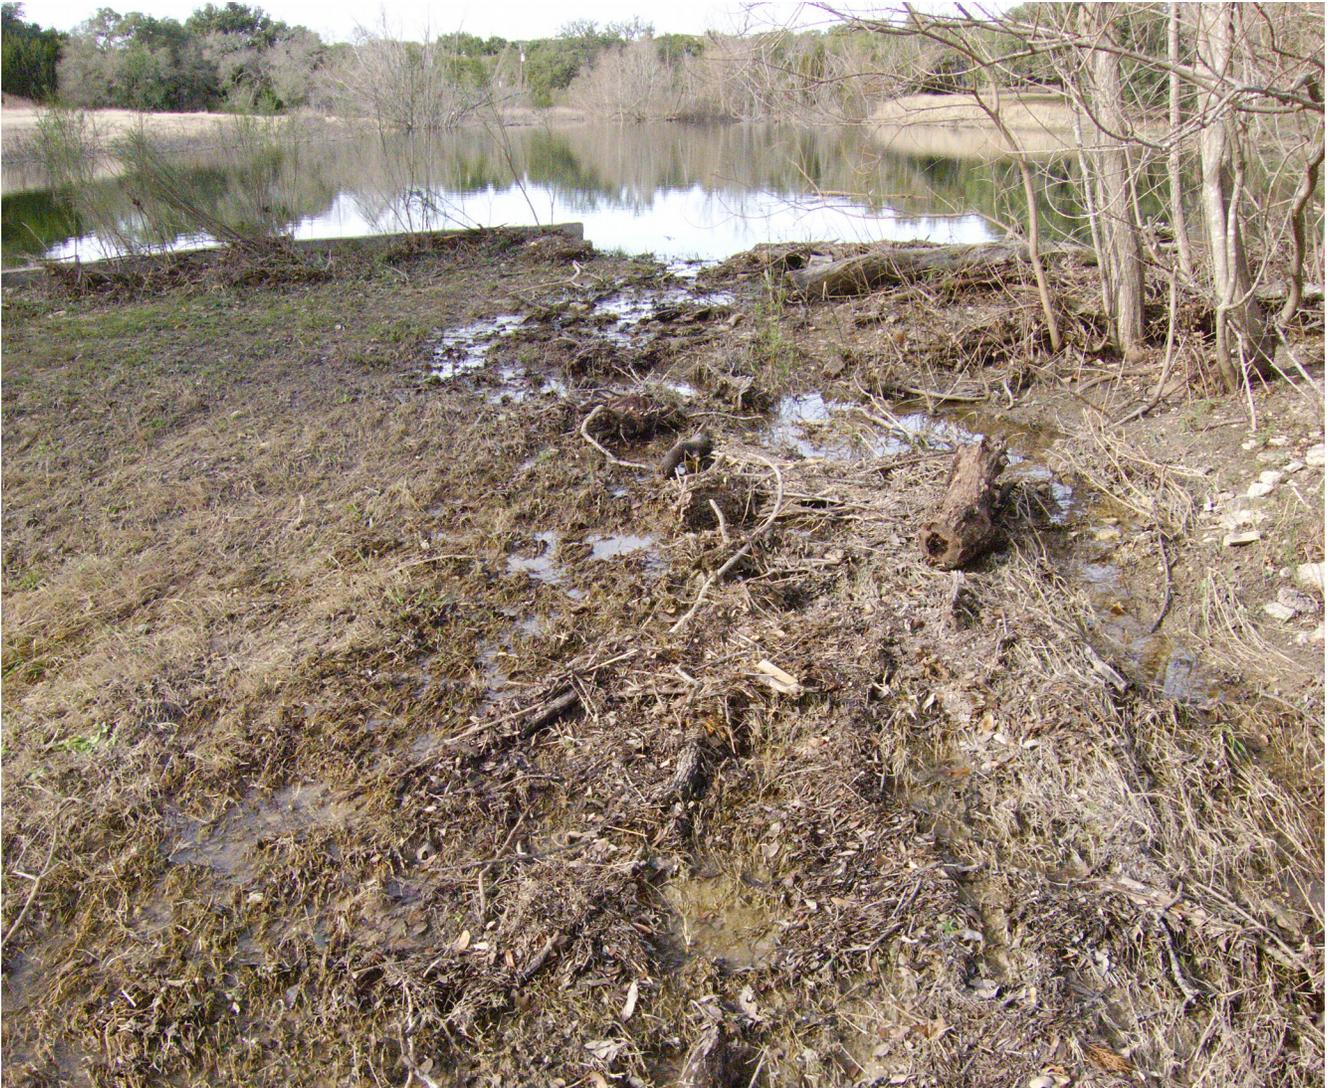
Issue #2. The lake bank. Because the bank has eroded, a great deal of water is escaping UNDER the mouth of the existing spillway.

*The above photo shows where water has breached the bank and found another path to the lower lake. The other side of the spillway is in similar condition with miniature waterfalls appearing alongside the spillway exit after heavy rains.*

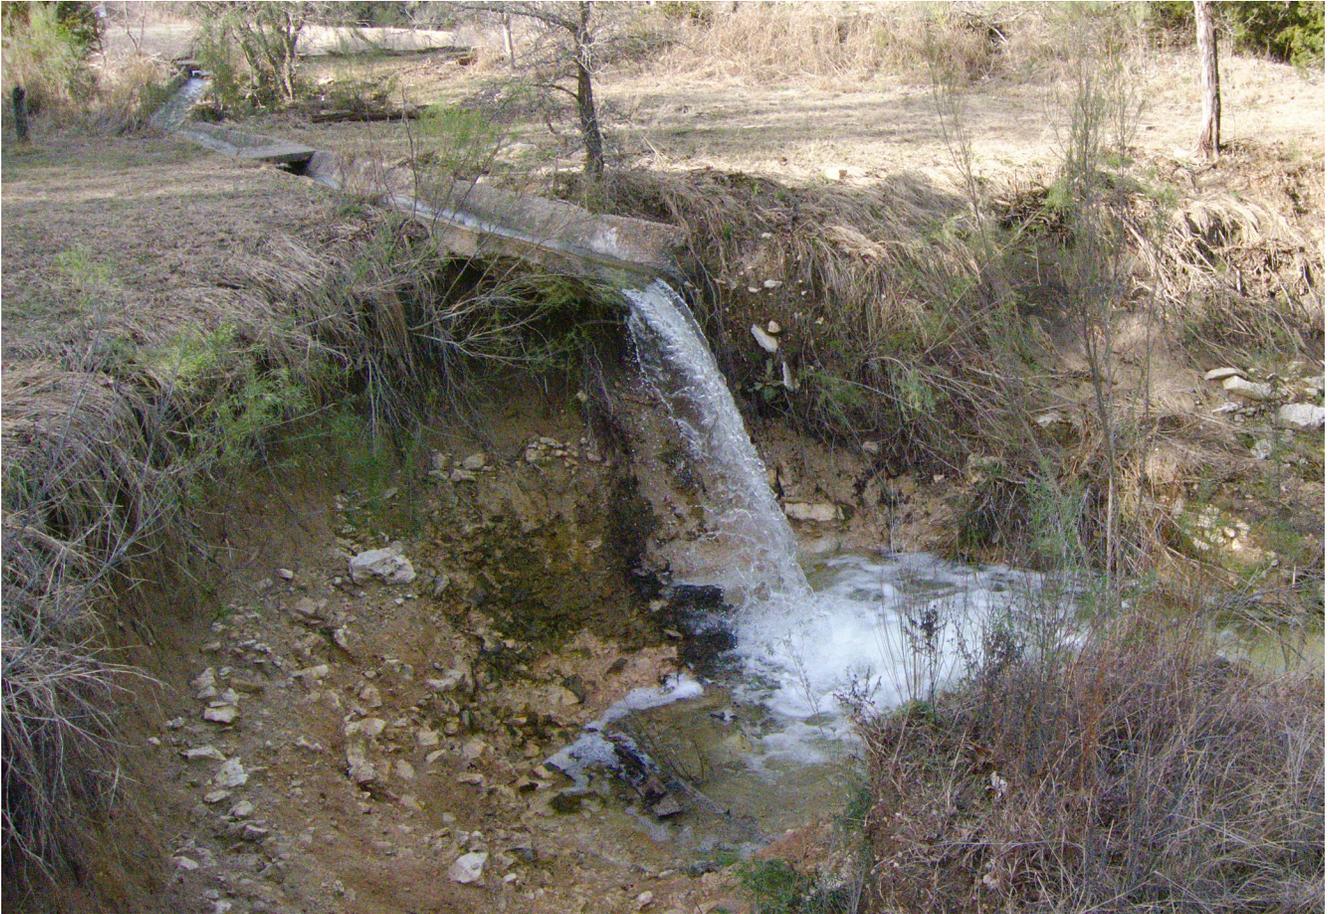
Issue #3. The overflow area. The “waterfall” created from the spillway has created erosion to the rock that is gradually working its way BACK toward the upper lake. In order to prevent further erosion, we are proposing dropping large rocks within the waterfall area.

*The above photo shows how erosion is working its way back to the upper lake. A large section of the concrete spillway has broken off because there is no longer ground to support it and it's likely the section hanging in mid-air will break off at some point, accelerating the erosion.*

Collier Materials would provide a load or softball - basketball size stones and with delivery cost would be approximately \$800.

TOTAL estimated cost to address the above issues is \$5800.

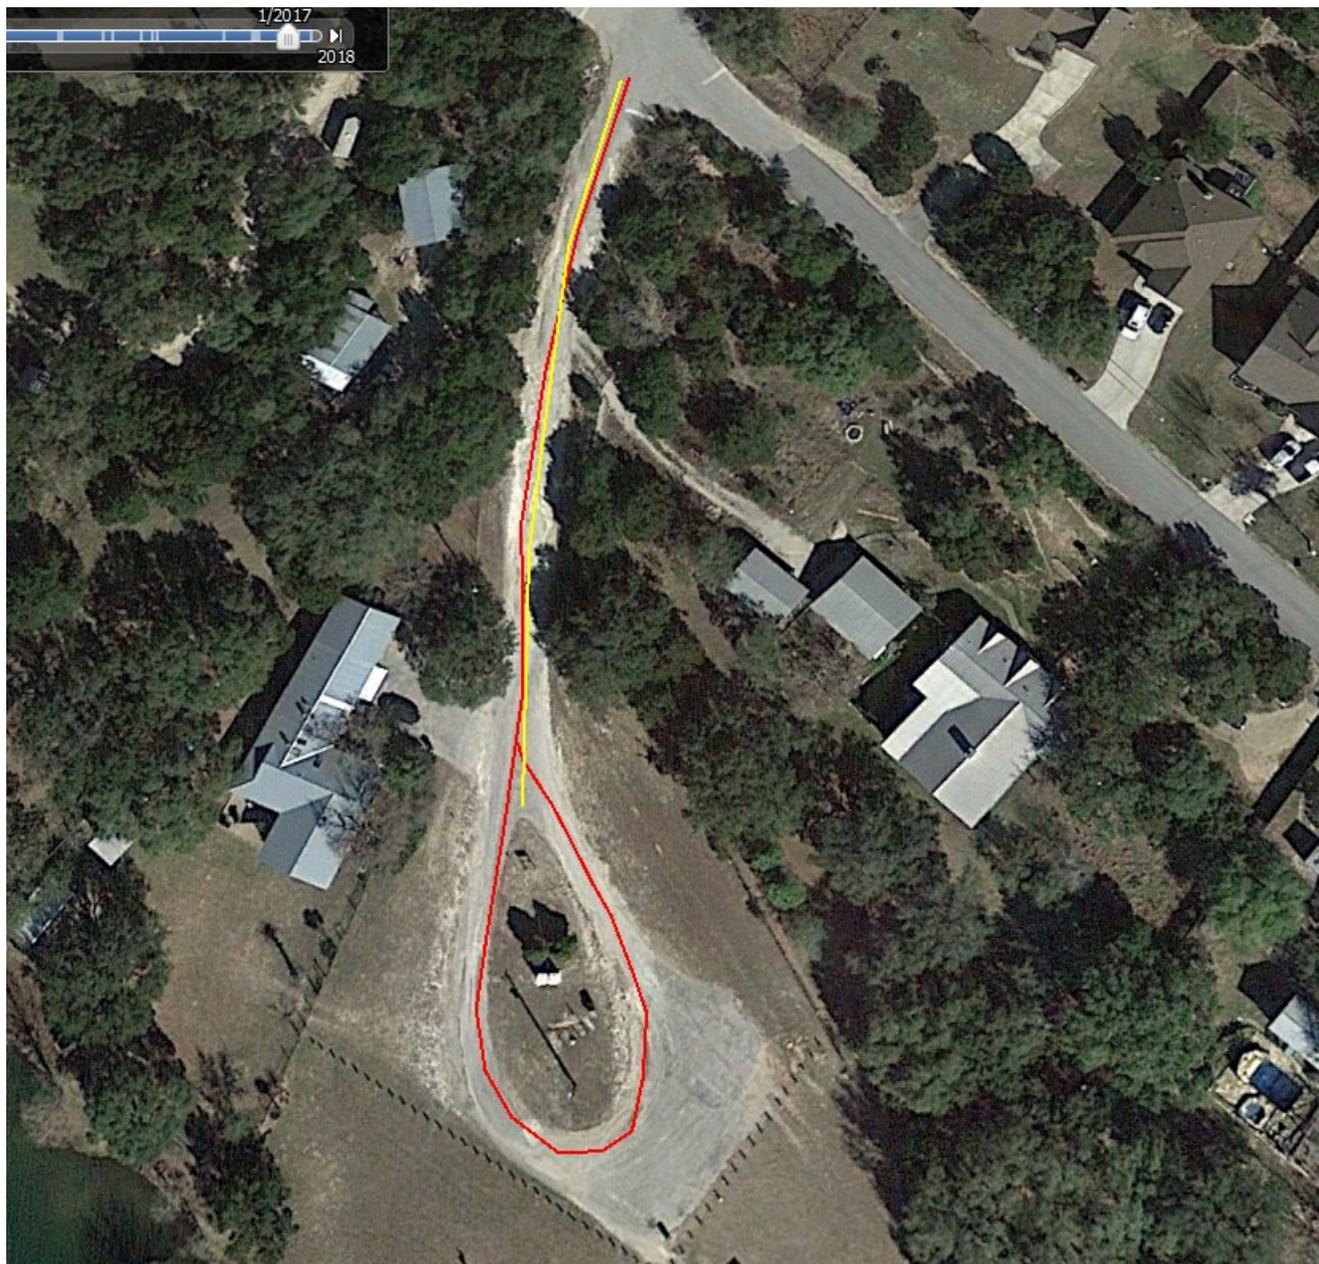
Key considerations: The entire stretch, with loop, is 625' (see red line below). The length without the loop is 315' (see yellow line). This stretch is not currently maintained by the county and desperately needs attention. It is nearly impassable by car and is unpleasant for larger vehicles. This has a big impact on members' ability to enjoy the playground, volleyball, and beach area and thus impacts residents' willingness to pay membership dues.

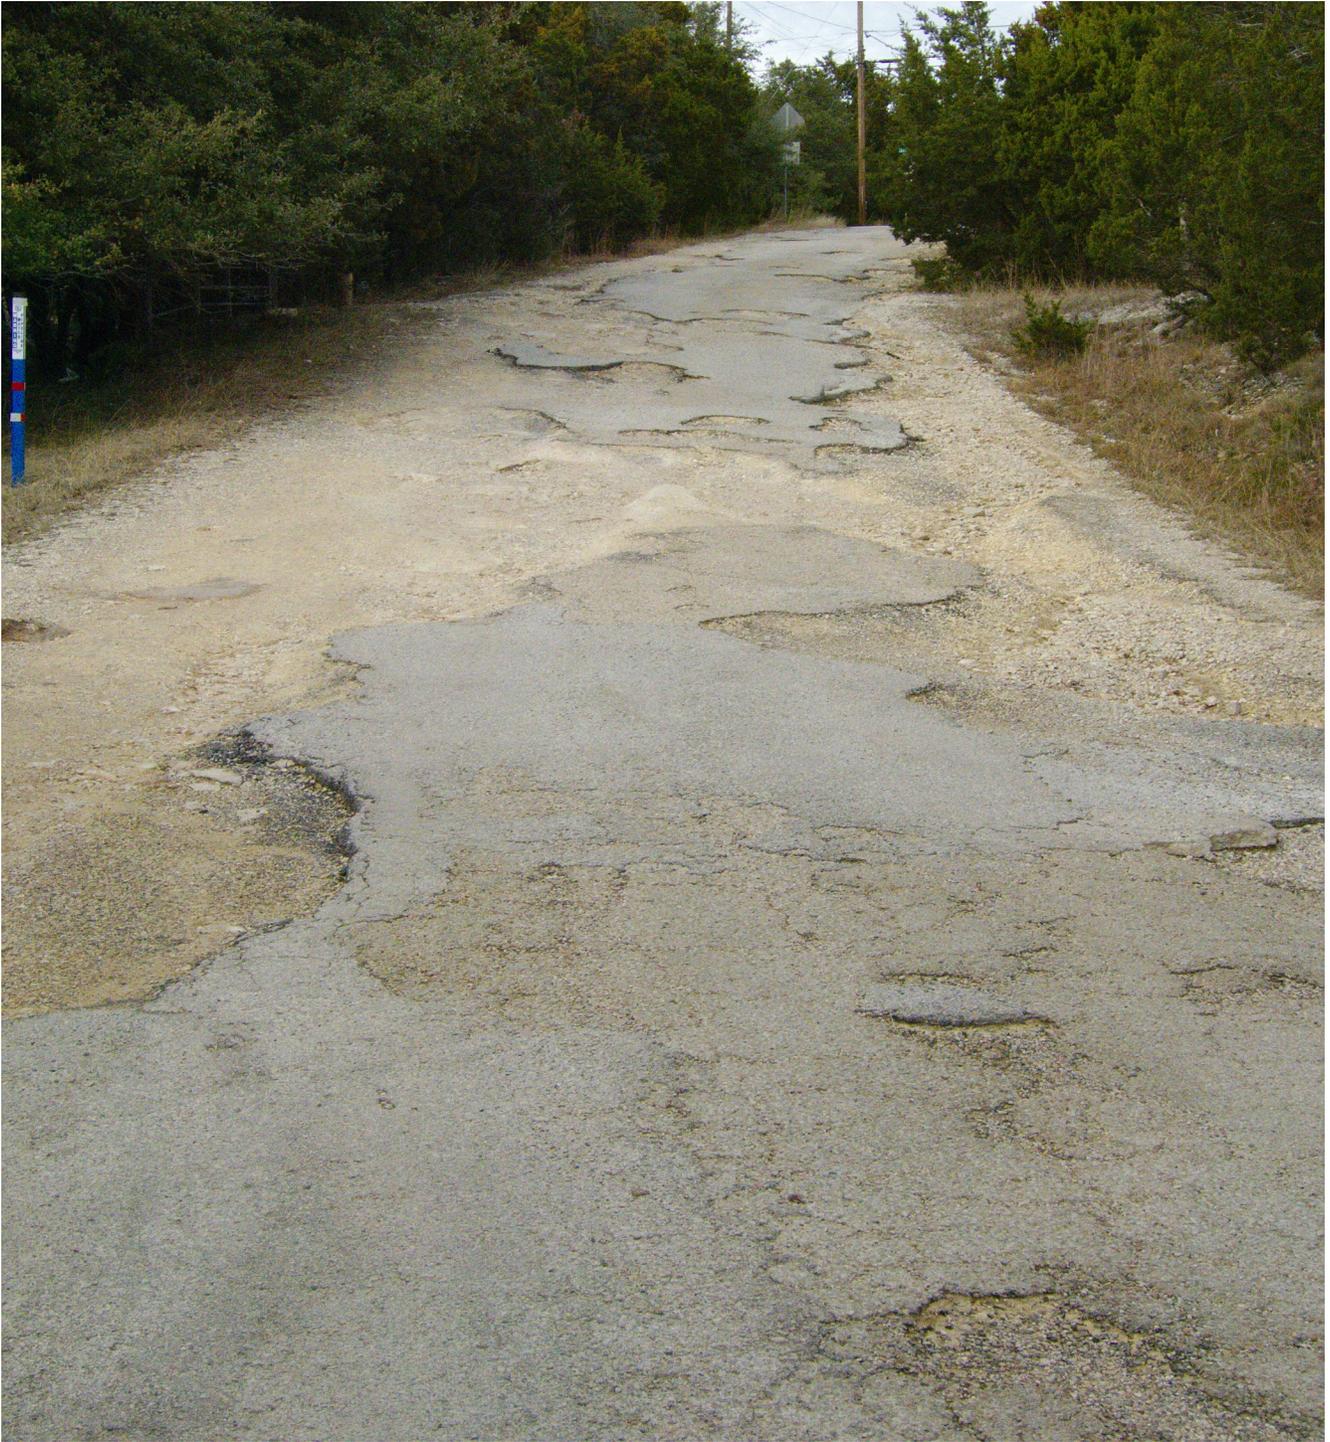
*Entrance to lower lake park (looking up toward the entrance). At this angle, the hazard it represents to vehicles is clear.*

Issue #1: Water rushes across this entrance on the way to the lake and has eroded the entry.

Option #1 Members of the community have offered their time and equipment to fill in large holes with rock and asphalt. This is a short term option with an

estimated 2-3 year lifespan before additional work will be required. Estimated cost: \$2,000-\$3,000

Option #2 This would require removing the existing asphalt, cutting trenches on either side of the road to channel water, and building up the center of the road so that water doesn't pool on the surface. The best quote to fix this the correct way was from Alpha Paving and it would be \$19,828.16.

Estimated cost: \$20,000

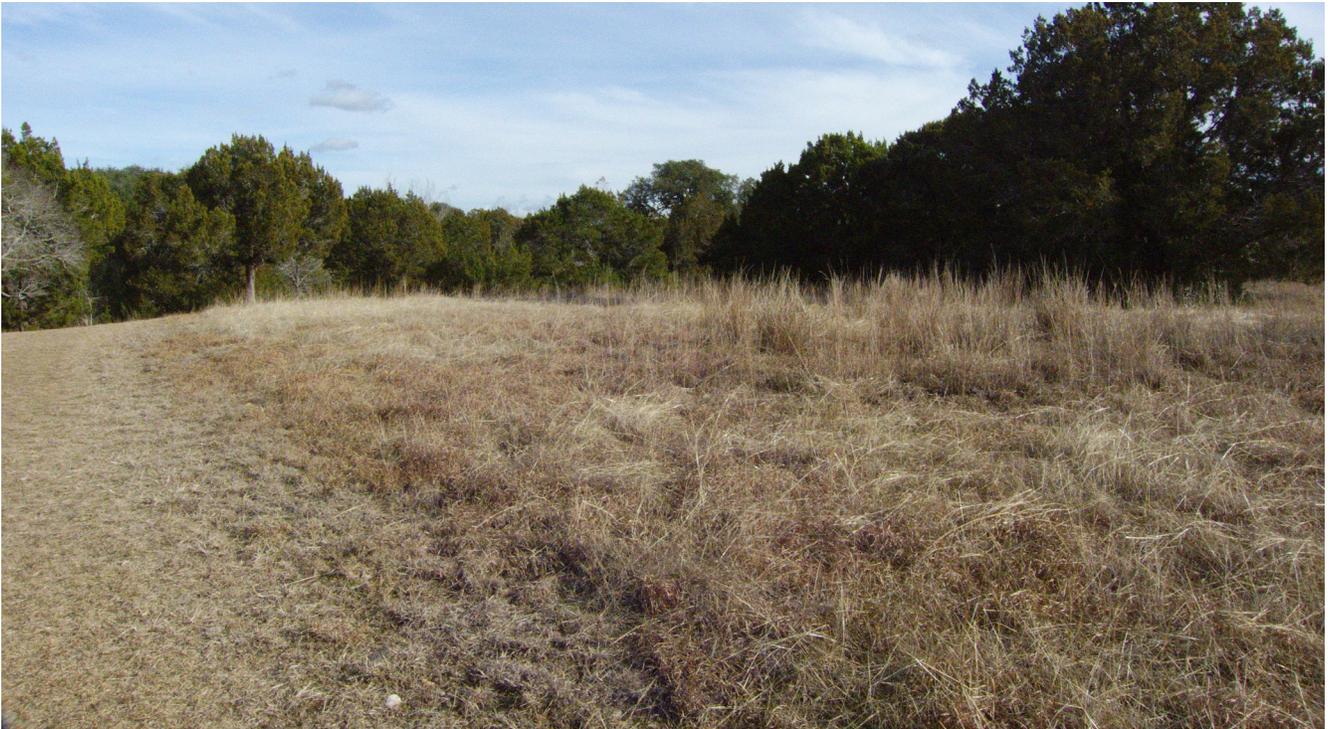
Key considerations: This area has only ever been used for burns, which have proven problematic. It is presently unused.

*Above photo shows the open field proposed as location for rock seat amphitheater between upper and lower lakes.*

Future Opportunity #1. Amphitheater. An amphitheater area similar to the one currently located at the Bee Cave Galleria can easily be created with stone blocks and/or rock cages. It is a low maintenance attraction that would provide an area for movies and nature classes in the park and serve as a good landmark to join the lower lake amenities with upper lake amenities. A trail marker in the area would serve double-duty as a Wi-Fi repeater for extending hot-spot access.

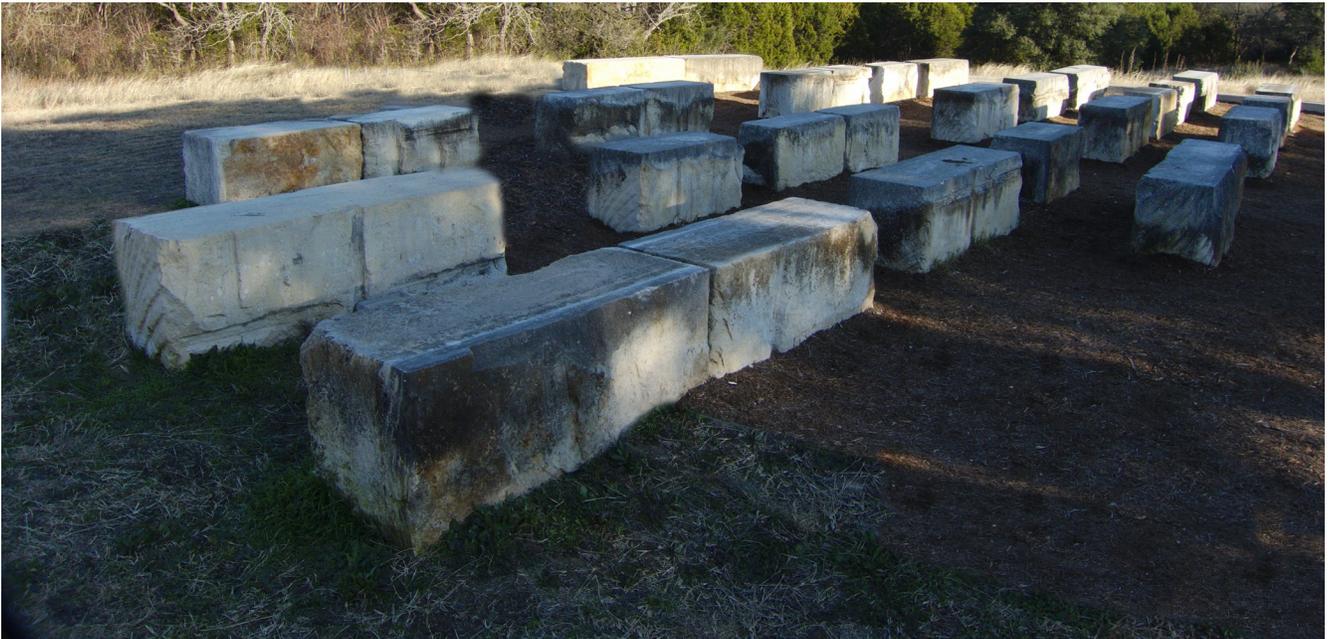
*The above photo was taken at the Bee Cave park and shows a rough approximation of what can be done using reasonably inexpensive stone. Proposed amphitheater would have stones in a more curved configuration.*

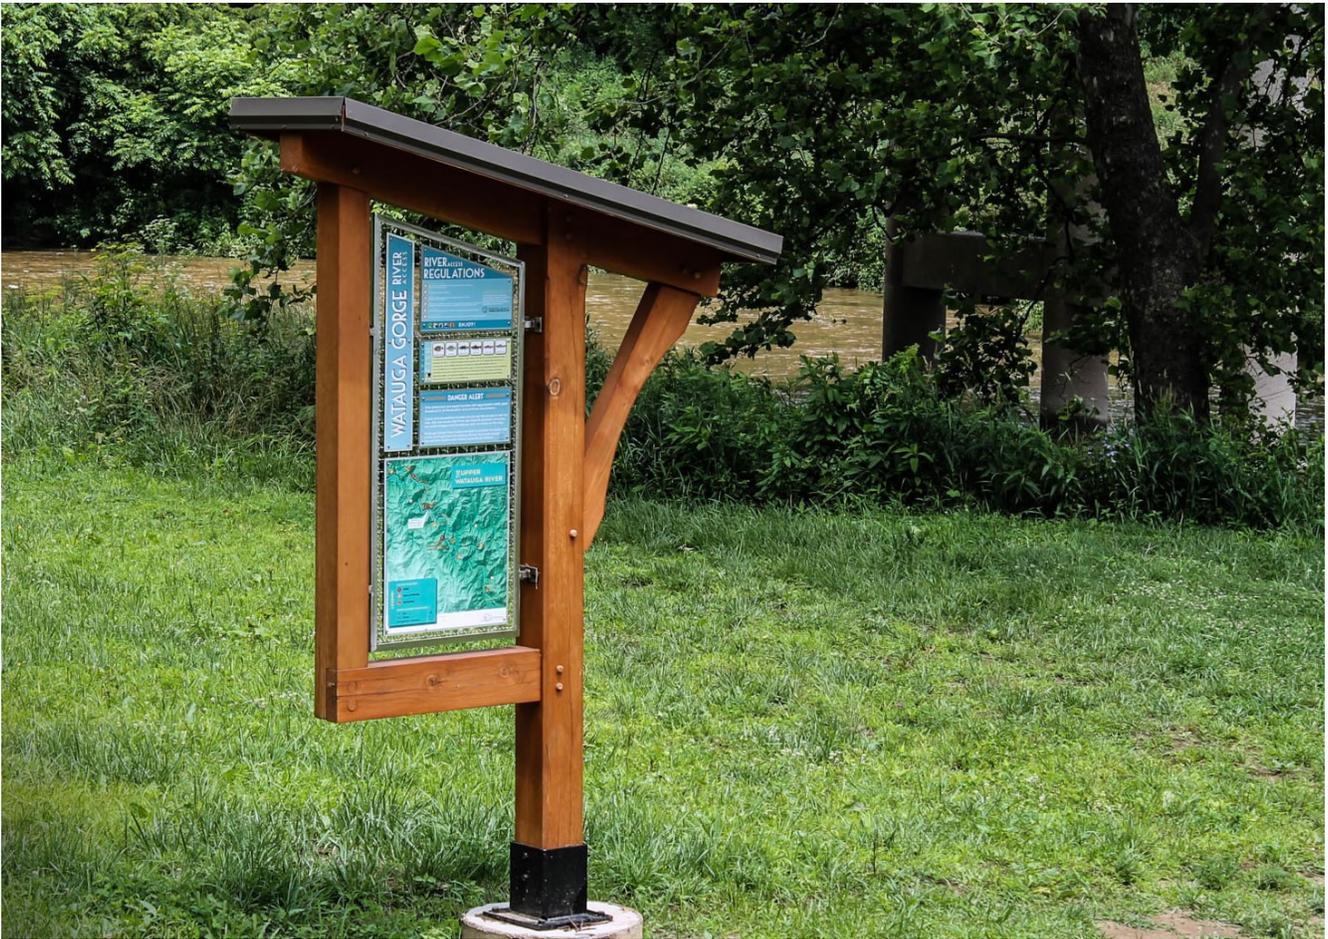
*A sample trail-marker in the area that could serve double duty as a Wi-Fi repeater.*

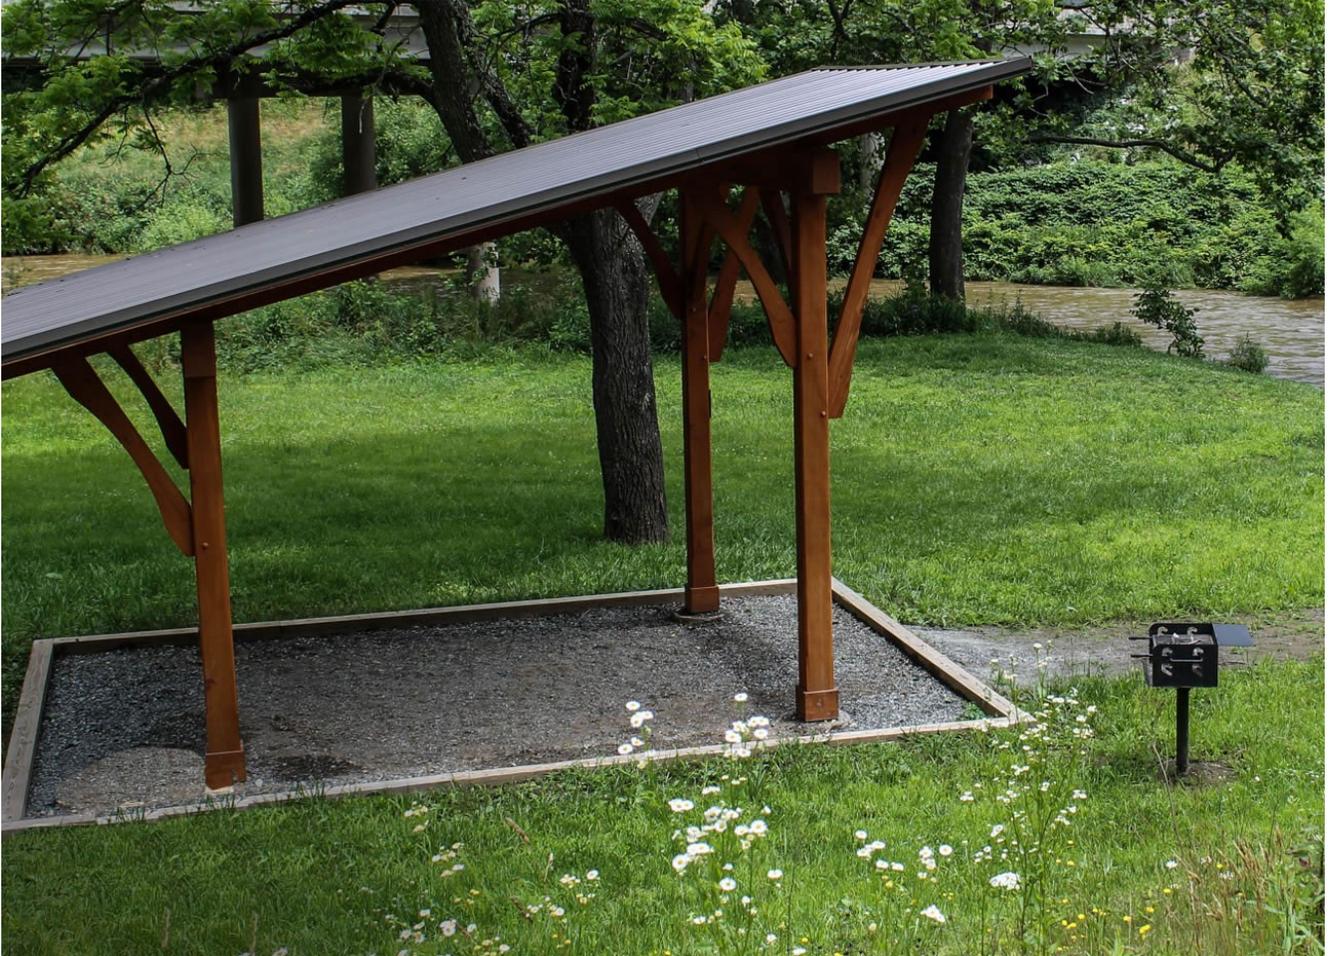
Future Opportunity #2. Small pavilion with electricity, wi-fi access, and security cameras. To help provide piece of mind to campers and residents alike, a small

(e.g. 12'x12' or 16'x16' pavilion) like the following would be constructed near the EXISTING electrical pole:

This structure would provide a centralized gathering spot for campers, a shelter in the case of severe weather, and help to extend Wi-Fi throughout the park. It would additionally provide limited electricity and offers a superb view of the upper lake.

Estimated cost: \$10,000-\$15,000.
